Safety reassessment of multiple arch dams in Italy: general considerations and presentation of a case-study

G. Mazzà
CESI S.p.A., Milan

3 THE MOLATO DAM CASE-STUDY

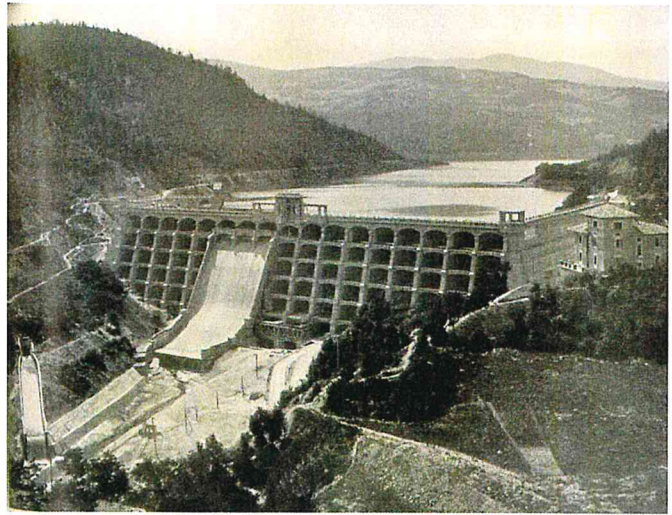
Figure 9. Downstream view of Molato dam

The dam operation has been restricted by the Dam Italian Service by reducing the retention water level of the reservoir, essentially for three reasons:

- the low sliding stability;
- the insufficient discharge capability of the outlets;
- the low resistance of the structure with reference to seismic loads mainly in the transversal direction.

In the present case the limited sliding resistance is connected to the original building characteristics

which have caused the complete covering of the buttress spans with large concrete slabs casted on the rock and the consequent possible rising of uplift pressures on the contact slab-rock.

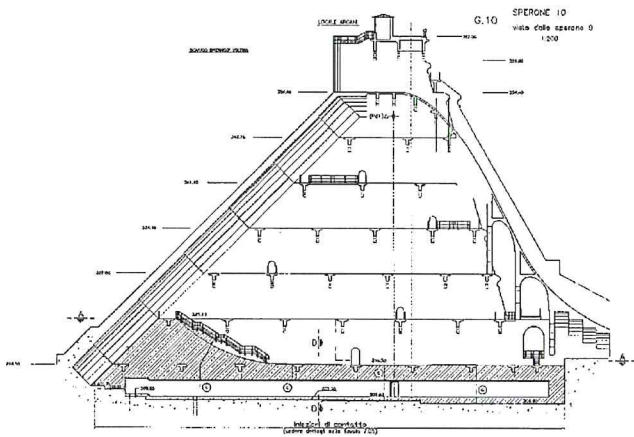
Figure 14. Partial filling with concrete designed for the rehabilitation of the dam

Only in the lower part of the buttresses high stress values have been found. On the other hand, the sliding assessment keeping into account uplift pressures has shown that for the highest buttresses the limits imposed by the Italian Standards are not fulfilled.

For these reasons, and with reference to the results related to the present dam state, the designer has chosen the solution shown in Figure 14.

The solution is represented by the partial filling with concrete of the lower part of the spans between the buttresses and the arches.

The building of these reinforcements allows to reduce the stresses in the lower part of the buttresses and to accomplish with the limits imposed by the Italian Standards for sliding.

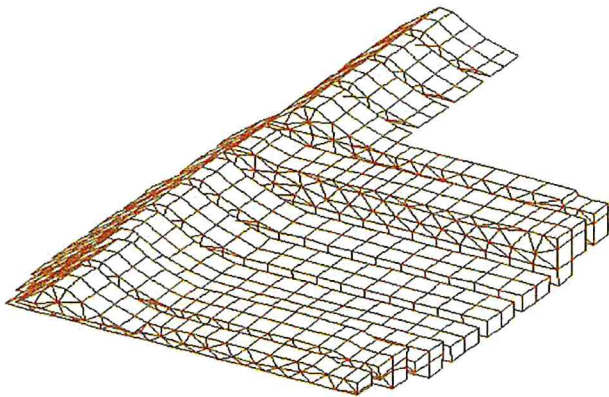
Figure 15. Numerical model of the partial filling for the rehabilitation of the dam.

In Figure 15 the numerical model of the partial filling with concrete of the lower part of the dam is shown.

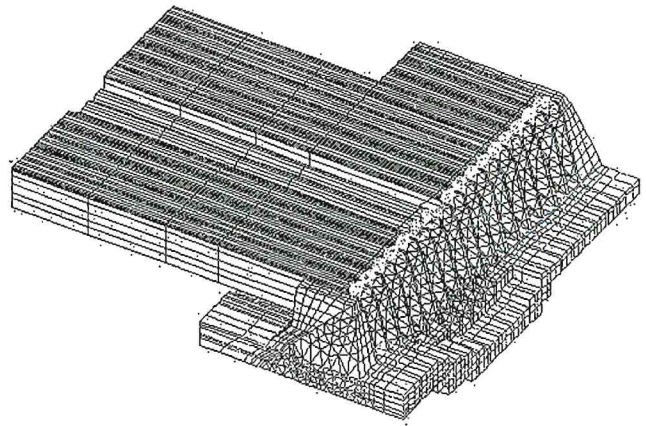
Figure 16. Finite element model adopted for numerical analyses.

With reference to seismic aspects, the analysis carried out with the model of Figure 16 has shown that the dam as it is at present is not able to withstand the seismic transversal loads mainly because of the limited strength of the reinforced concrete T-arches which connect the buttresses.

For this reason it has been designed a suitable reinforcement and replacement of the T-arches and their beneficial effect has been assessed making reference to a fully dynamic (response spectrum) analysis which takes into account the fluid-structure interaction (Bolognini et al., 1995). A typical modal shape computed to carry out the dynamic analysis is shown in Figure 17.
